Southern Peru desert shattered by the great 2001 earthquake: Implications for paleoseismic and paleo-El Niño–Southern Oscillation records

David K. Keefer*[†] and Michael E. Moseley[‡]

*U.S. Geological Survey, MS 977, 345 Middlefield Road, Menlo Park, CA 94025; and [‡]Department of Anthropology, University of Florida, Gainesville, FL 32611

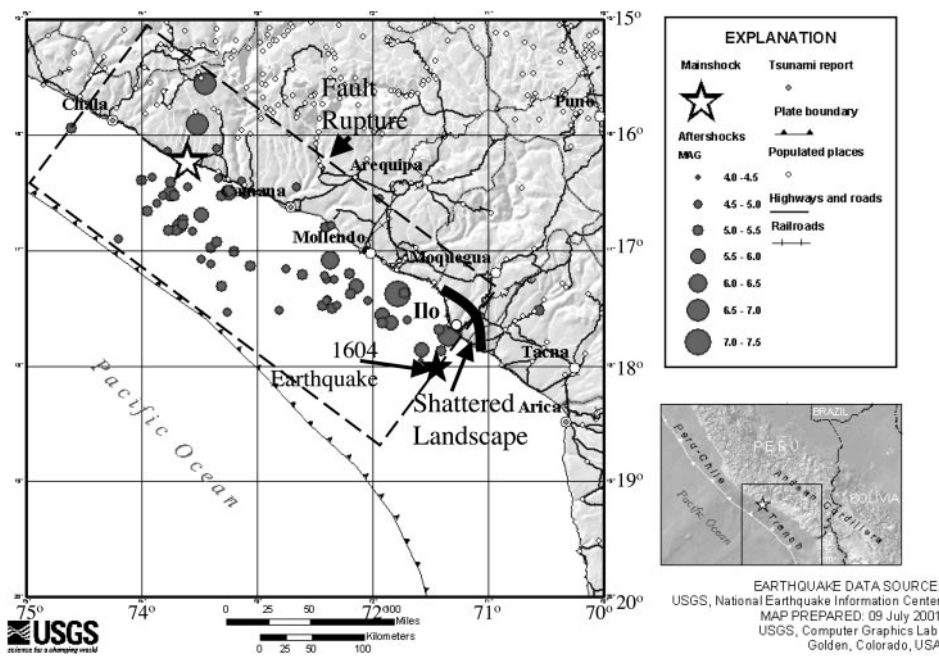
Fig. 1. Location of the seismically shattered desert landscape in southern Peru; epicenter and main aftershocks of the June 23, 2001, earthquake and principal cities in the region (from the U.S. Geological Survey); inferred fault rupture of the 2001 earthquake (from ref. 5); and inferred epicenter of the 1604 earthquake (from ref. 18).

The southern Peru earthquake of June 23, 2001, had an M_w of 8.2–8.4. The hypocenter was 30- to 33-km deep and located near the coast at 16.26°S, 73.64°W (4) (Fig. 1). Much of the energy release and the largest aftershock (M_w 7.6) occurred far to the southeast of the hypocenter, in the part of the fault-rupture zone nearest the study area of shattered-landscape effects (4). Within Peru, the earthquake shaking was recorded on only one strong-motion instrument, located in the city of Moquegua, ≈ 60 km NNE of the city of Ilo, which is in the center of the study area. There the peak ground acceleration was a moderate to high $0.30 \times g$, and the significant duration was a relatively short 36 sec (7). Damage in the central part of Ilo, in which bedrock is at or near the ground surface, was minimal, whereas in outlying areas built on softer materials, local damage ranged from minimal to severe (7). The regional-scale mapping of seismic intensities (5) rated the maximum earthquake shaking intensity as a modified Mercalli (MMI) VIII (relatively low for an earthquake of this magnitude) and intensities within the study area as MMI VII–VIII. However, the intensity of the shattered-landscape effects suggests that shaking was more severe locally than indicated by this regional-scale mapping.

The study area extends for a distance of ≈ 80 km along the coast around the city of Ilo and for several kilometers inland (Fig. 1). The main physiographic features in this area are a sea cliff of variable height, a narrow coastal plain, a series of prominent alluvial fans drained by incised “quebradas” (arroyos, or normally dry drainage channels), and the Coastal Cordillera, a mountain range on which the highest peaks are 1,600–1,800 meters above sea level. Midway through the study area, the Osmore drainage basin, which cuts through the Coastal Cordillera to the high Andes, meets the sea at the port city of Ilo (Fig. 1). Rocks making up the Coastal Cordillera are generally well indurated, but in many places they are intensely fractured or exhibit multiple sets of prominent, open joints, which are char-

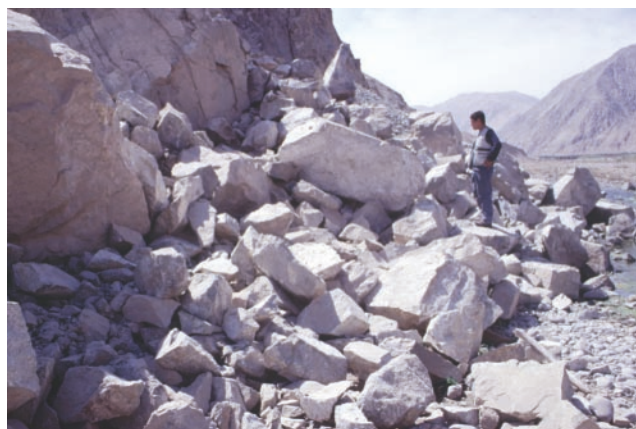
Fig. 2. Rock fall in the lower Ilo valley, one of several thousand mostly disrupted landslides triggered by the 2001 earthquake.

Within the shattered landscape, landslides occurred on steep artificial cuts such as for roads, as well as on valley walls, and drainage channel (or quebrada) banks (Fig. 2). Most landslides were rock falls, rock slides, soil falls, or disrupted soil slides (fast-moving, shallow, highly disrupted landslides that typically carry boulders, rock fragments, small blocks of poorly consoli-

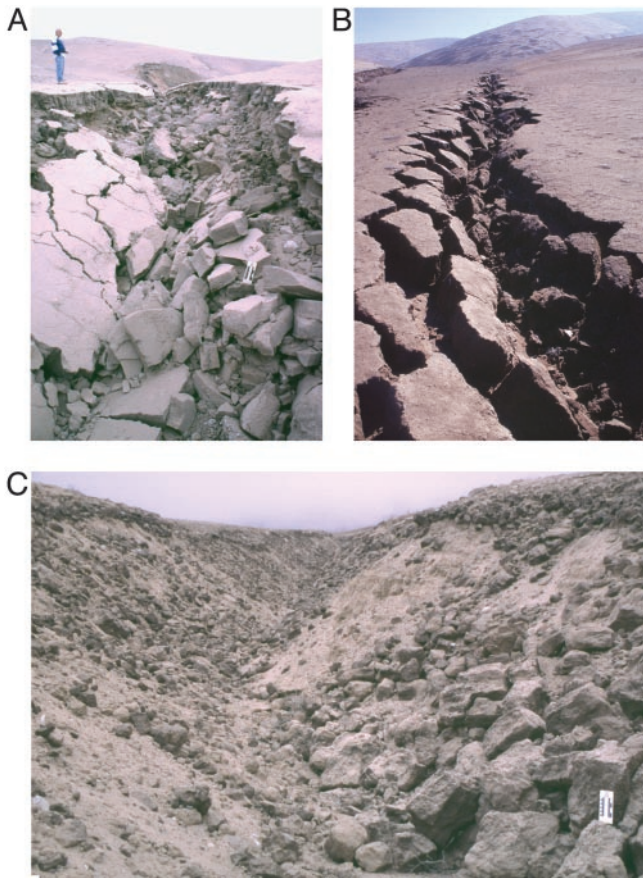
Fig. 3. Collapsed quebrada banks in the shattered landscape. (A) Collapse of banks composed of cohesive crust underlain by largely cohesionless sand produced a deposit consisting of a mixture of large blocks and sheets of loose, fine sediment. The scale shown is marked in inches and centimeters. (B) Detachment of large polygonal blocks, on the order of 1 m long, significantly widened this quebrada channel while also providing substantial amounts of sediment for entrainment by postearthquake runoff. Dark patches on the ridge in the background are zones of shattered ground. (C) Sediment from seismically shattered banks choking the bottom of a quebrada. The scale shown is marked in inches and centimeters.

Banks of quebradas incised into coastal alluvial fans and foothills experienced pervasive collapse, which widened the upper portions of the channels while choking the channel bottoms with sediment (Fig. 3). In areas of the most intense collapse, several thousands of cubic meters of loose sediment were delivered to the bottom along each linear kilometer of quebrada channel. Typical stratigraphy exposed in the areas of collapse consisted of a three-layer sequence. The upper layer was a 10- to 50-cm-thick cohesive crust of aeolian sand, evidently held together by negative pore-water pressures (soil suction). Underlying this crust was a thinner, heavily structured, black organic *lomas* soil, and below that was a variable sequence of cohesionless aeolian sands interbedded with coarser and more consolidated flood and debris-flow deposits extending to the channel bottoms. In areas of bank collapse, the more cohesive crust and *lomas* soils typically formed blocks several tens of

centimeters on a side, whereas cohesionless underlying materials formed sheets of loose sediment (Fig. 3).

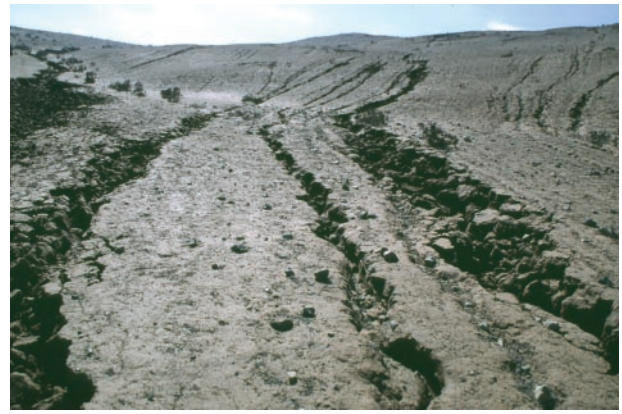
Fig. 4. Multiple rills widened by earthquake-induced collapse of their banks. Rills in the foreground are $\approx 0.1\text{--}1.0$ m wide.

Upslope from most quebradas, hillsides are incised by systems of shallow rills, 10–25 cm deep, which are linear and trend down the local gradient. These rills channel runoff along with any entrained sediment from the hillslopes into the quebradas during rainstorms. Rills, too, experienced extensive caving of their banks, thus widening them and increasing their capacity to transport runoff and sediment from hillslopes to quebradas (Fig. 4). In some areas, rills were connected to quebrada channels by systems of short, underground natural conduits or pipes, generally cut into or through the *lomas* soil and having roofs composed of cohesive crust. The earthquake also caused such pipes to collapse, thus adding to the length of existing quebradas.

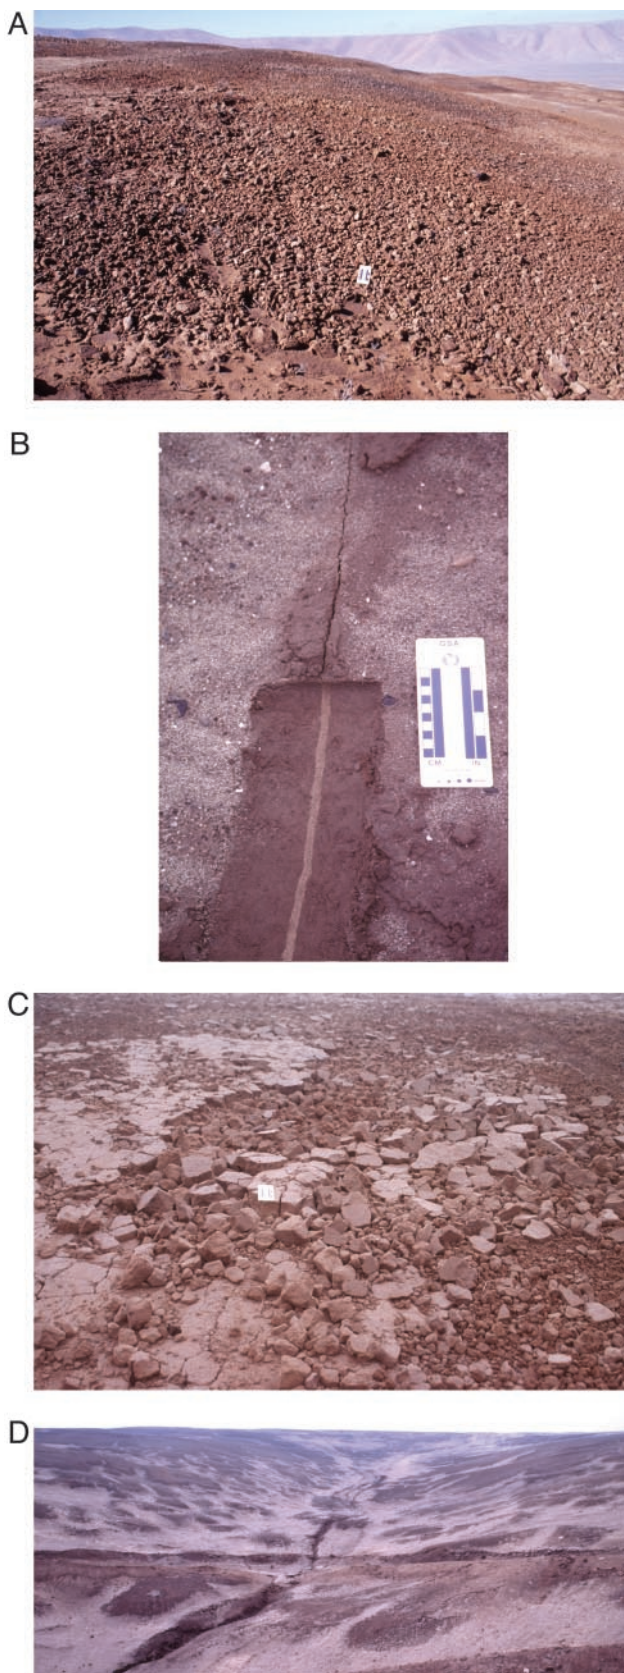
Fig. 5. Zones of cracked and shattered ground on ridge flanks. (A) Zone in which surficial materials have been shattered into fragments a few millimeters to a few centimeters on a side. The scale shown is marked in inches and centimeters. (B) An earthquake-induced ground crack (upper part of photograph) follows the trace of an older ground crack filled with aeolian sand (light material in

lower part of photograph), as shown in shallow excavation. The scale shown is marked in inches and centimeters. (C) Zone of cracked ground grading into a zone of shattered earth. The scale shown is marked in inches and centimeters. (D) Closely spaced zones of shattered ground (dark areas) on hillslope. Note the unpaved road traversing the central part of the photograph for scale.

Many hillslopes in both alluvial fan and foothill areas contained zones in which at least the cohesive surface crust and *lomas* soil were cracked or shattered. Intensities ranged from zones with cracks spaced on the order of 1 m apart to microfracturing of the soil into fragments only a few millimeters on a side (Fig. 5). In areas of the least intense cracking, ground was broken into polygonal blocks separated by fissures a few millimeters to more than 1 cm wide, and the surface resembled a jigsaw puzzle in which the pieces did not quite fit together. A few shallow excavations showed that at least some fissures were coincident with older cracks that were filled with aeolian sand (Fig. 5B). Whereas the extent of this coincidence in location is unknown, the collocation of at least some ground cracks from the 2001 earthquake with older cracks suggests that this seismic shattering has been a recurrent phenomenon.

Many zones of hillside cracking graded into areas of thoroughly shattered earth (Fig. 5C), in which the surficial crust and *lomas* soil had been fractured down to the millimeter scale, producing a chaotic jumble of small fragments. This fracturing was so violent that small *lomas* plants were uprooted and thrown out of the ground. Zones of the most thoroughly shattered earth were concentrated on the downslope flanks of small-scale, local topographic convexities. Some ridge flanks had many areas of ground cracks and shattered earth spaced at close intervals (Fig. 5D).

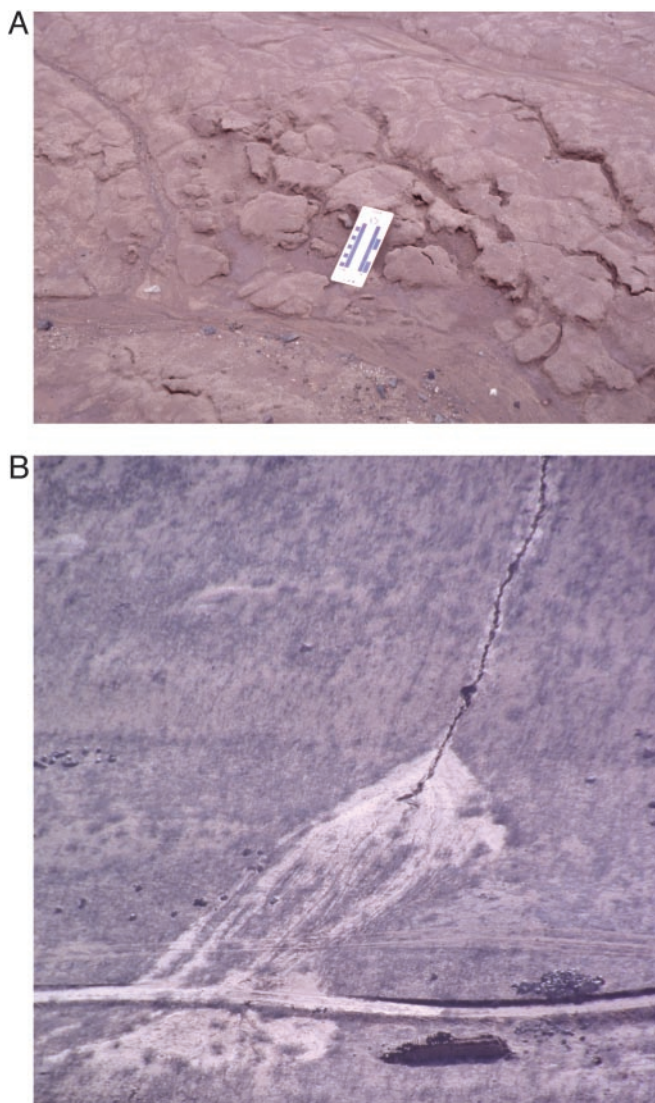
Fig. 6. Effects of the June–July 2002 rainfall event on the shattered landscape. (A) Earthquake-induced ground cracks provided channels for runoff, which eroded the edges of polygonal blocks and entrained sandy sediment in flow. The scale shown is marked in inches and centimeters. (B) Fan-shaped deposit of sediment (light-colored material) washed over an unpaved road from an earthquake-widened rill.

After the July 2–3 showers, our field observations revealed that even this small amount of precipitation had significant effects on the shattered landscape. It caused runoff, erosion, and sediment transport through all parts of the coastal drainage system from cracked and shattered hillsides, through widened rills and conduits, into collapsed quebrada channels, and down to the sea. Excavations revealed that rain infiltrated into the soil to an average depth of ≈ 10 cm on hillsides. Ground cracks produced by the earthquake served as small channels for runoff, which rounded the previously sharp edges of blocks and entrained sediment from their edges (Fig. 6A). In areas of shattered earth, the runoff transported shattered fragments of soil downslope. In areas where runoff was concentrated, new gulying was initiated in areas that previously lacked rills. Where the earthquake had widened existing rills, runoff through them created new sediment deposits (Fig. 6B). Concentrated runoff flowing through collapsed pipes and quebrada channels transported sediment along them also, in some cases winnowing out the fine material from earthquake-induced bank collapses and leaving coarse lag deposits behind. After the rainfall episode, water continued to trickle down some quebrada channels for several days.
